## Investigation of Structural Integrity and Stability Evaluation of Fire affected Building by Non-Destructive Testing

### Abstract

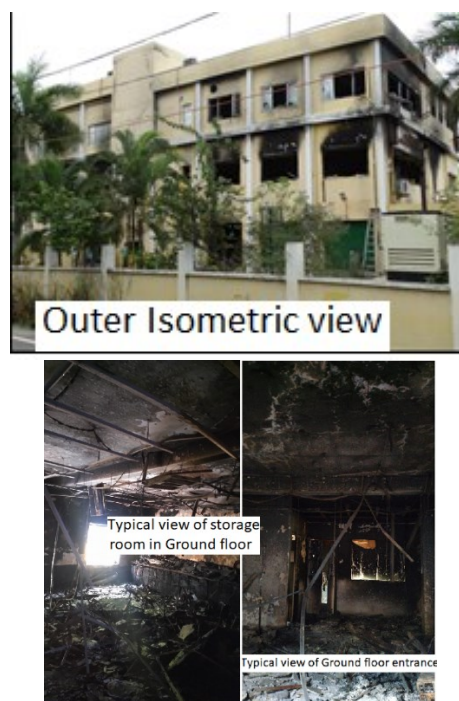
The post fire analysis is started with investigating the structure with visual observation. In general, visual inspection can partly decide on the quality and integrity of fire affected building for taking a decision on the possibility of further operation of the facility. The typical view of fire affected building is shown in figure.1. The fire affected building is of G+2 story with RCC framed structure and partially loading brick masonry. RCC columns are placed in three rows along the length directions. These columns are spaced at 3.0 m intervals along the longer directions.

**Fig.1** Typical view of fire affected building – Outer and ground floor

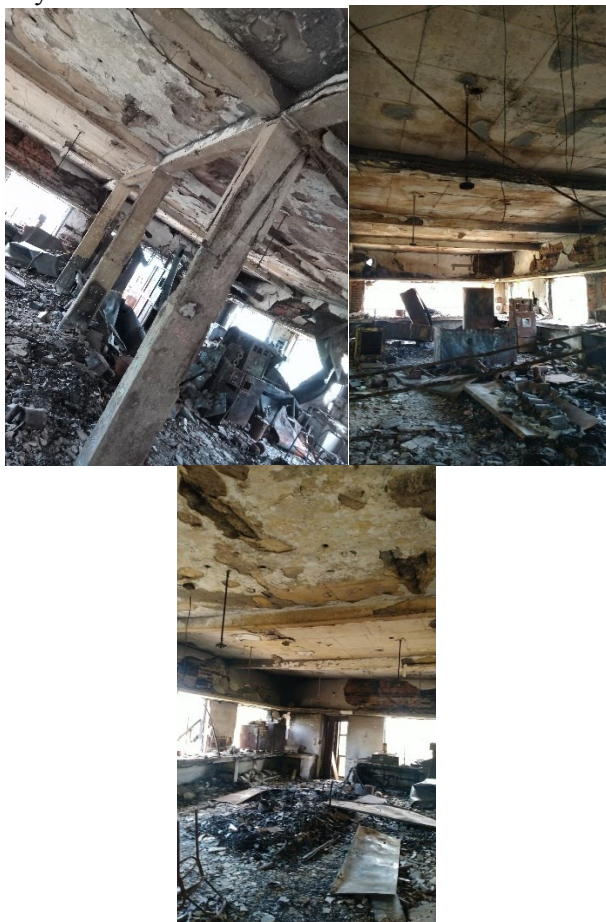
made the structure to exposed in high temperature. The brick infills have lost the mortar cover and cracked severely, but the brick infills have protected the beams and columns during fire. Unlike the ground floor, the first floor is seeming to be worst affected by the fire incident as shown in figure.2. This floor doesn't have a partition walls around the interior columns and beams. A full height wooden cabinets as partitions with chairs and wooden tables are provided in this floor. Inflammable chemicals and resins are stacked in few cabins. The official paper and patent documents, computer CPU's and monitors are kept in the cabins. During fire, the inflammables kept in the first floor is fuelled the fire heavily. The cabinets to carry out different research activities.

**Fig.2** Typical view of fire damage in first floor of fire affected Building

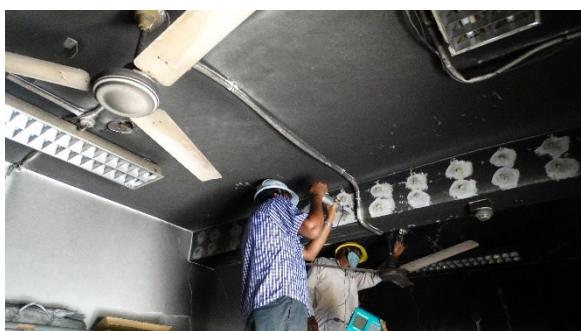
**Fig.4a** Typical view of Rebound Hammer Test in ground floor

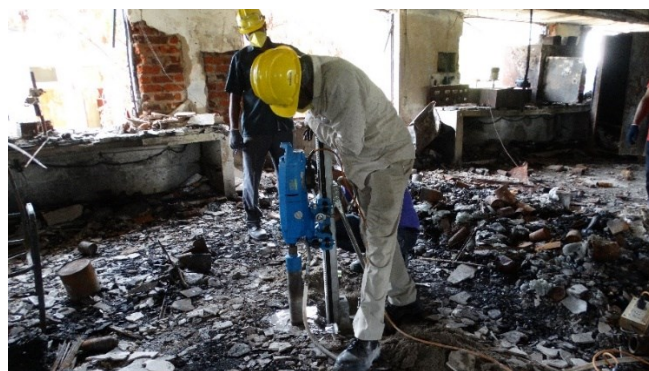
**Fig.5** Concrete Core Extraction on Slab in Progress

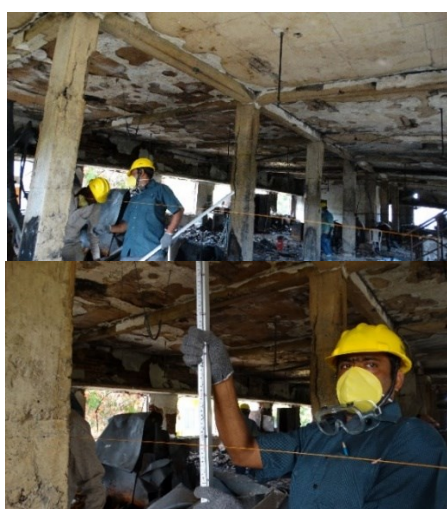
**Fig.6** typical view of levelling and the measurement of sectional deflection

The deformation of beams and slabs were measured on selected portions and the maximum level difference is presented in table.2. The measured deflections are checked for the flexural stability checks as per prescribed in the Indian code of practice [6]. The deflection measured in the beams and slabs are exceeds the limiting deflection at first floor level. In second floor level, the beams and slabs in affected area partly fulfils the design criteria and partly exceeds the design criteria for the stability checks.

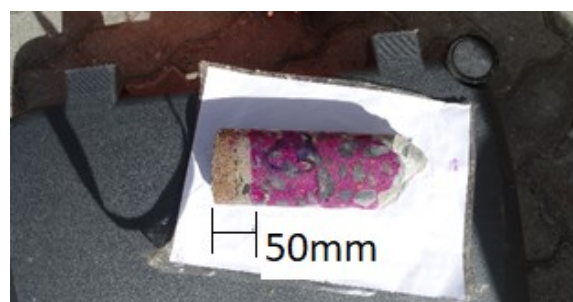
solution was first applied to their side surfaces that were affected by the fire without treating the surfaces. As shown in figure.7. the colour did not change in cover region up to 40 mm and with a purple area where the alkaline concrete reacted to the indicator for the sample extracted in fire affected zone. Whereas the test was conducted for the core samples extracted from unaffected area indicates fully change in colour which shows that the concrete is of fully alkaline in nature. Therefore, the concrete cover of 40-50 mm have experienced a maximum temperature of more than 600°C.

**Fig.7 Neutralization Test on Extracted Concrete Core Sample**

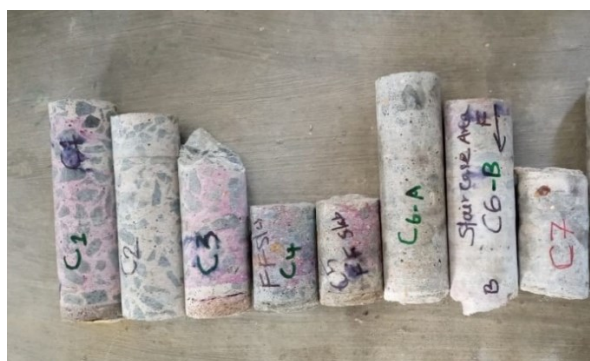
**Fig.8a Extracted Concrete Samples**

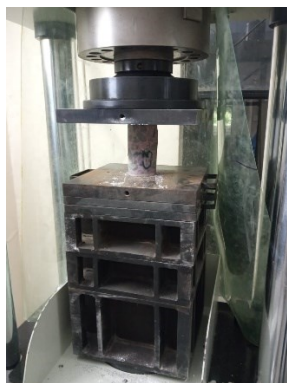
**Fig.8b** Concrete Core under Compressive Load

The acceptance criteria with respect to cube strength obtained by testing concrete core i.e. individual specimen shall be at least 75% and average strength shall be at least 85% of the concrete strength considered in design. From the test results, it is observed that the concrete strength in unaffected areas was about 23.25 MPa and at the affected areas is ranging from 8.72 MPa to 13.30 MPa, which 60 % reduction lesser strength compared to unaffected areas. The strength of concrete is fails to satisfy the design

criteria and needs to restored with appropriate strengthening measures.
